THAMES RIVER BASIN

STAFFORD, CONNECTICUT
WARREN POND DAM
CT 00335

PHASE I INSPECTION REPORT
NATIONAL DAM INSPECTION PROGRAM

AUGUST 1980

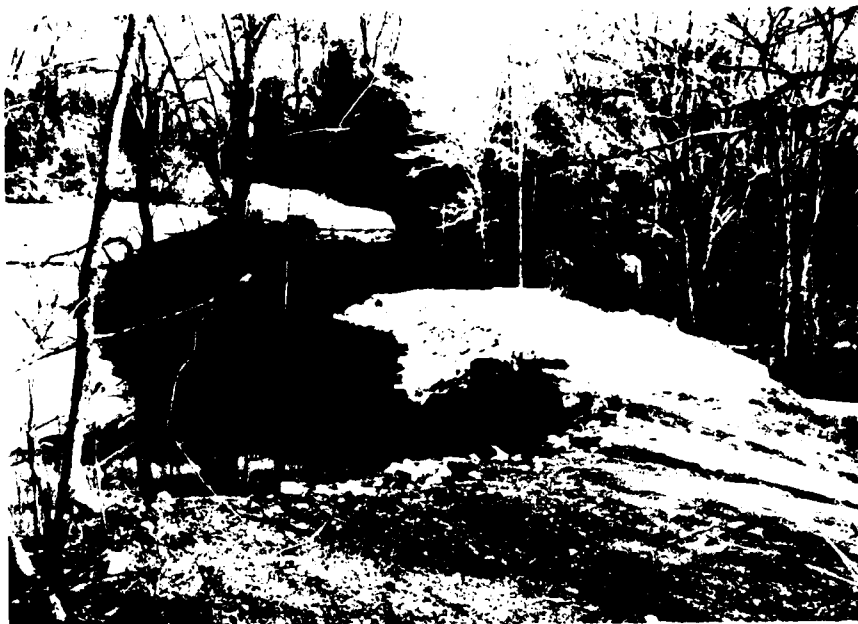
c. Appurtenant Structures - The masonry culvert through the right embankment section of the dam and the outlet canal are both in poor condition (Photos 1 and 3). There is no gate hoisting mechanism on the upstream headwall of the culvert. Fallen masonry blocks at the right corner of the upstream headwall of the culvert were observed, leaving exposed and eroded earthfill. The left masonry wall of the outlet canal, with concrete coping on the top, was deteriorated with numerous cracks in the concrete and opened, weathered masonry joints. There is a 12 inch cast iron drain pipe

Photo 1 - Upstream slope and top of dam. Upstream headwall of canal intake culvert in foreground (3/24/80).

6. The cracked and damaged masonry of the culvert upstream headwall and canal training wall should be reinforced.
7. Additional boulders for energy dissipation should be placed at the right side of the spillway apron and other suitable measures should be undertaken to prevent erosion of the spillway downstream channel bank.

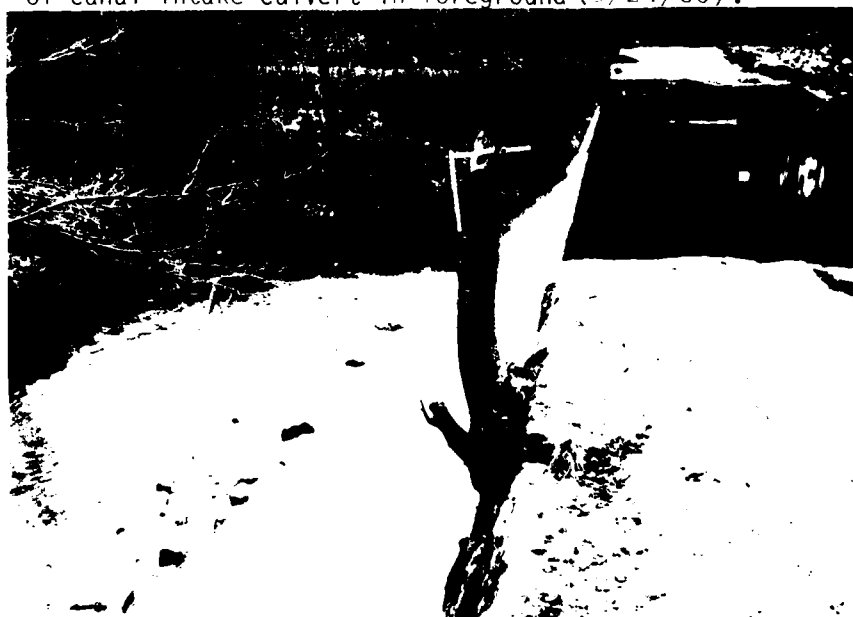
Spillway - The masonry spillway crest is in good condition. No substantial obstructions of the approach channel or crest were observed (Photos 1 and 2). The training walls adjacent to the spillway crest were cracked, with joint openings between blocks of up to 2 inches. The concrete apron at the toe of the spillway could not be observed, due to the amount of water flowing onto it from over the spillway. The energy dissipation boulders on the apron were sparse towards the right side of the channel and, consequently, there is extensive erosion and uprooted trees along the right side of the downstream channel (Photos 2 and 5).

Photo 2 - Spillway and spillway discharge apron. Note tree stump and uplifted masonry block in foreground (3/24/80).

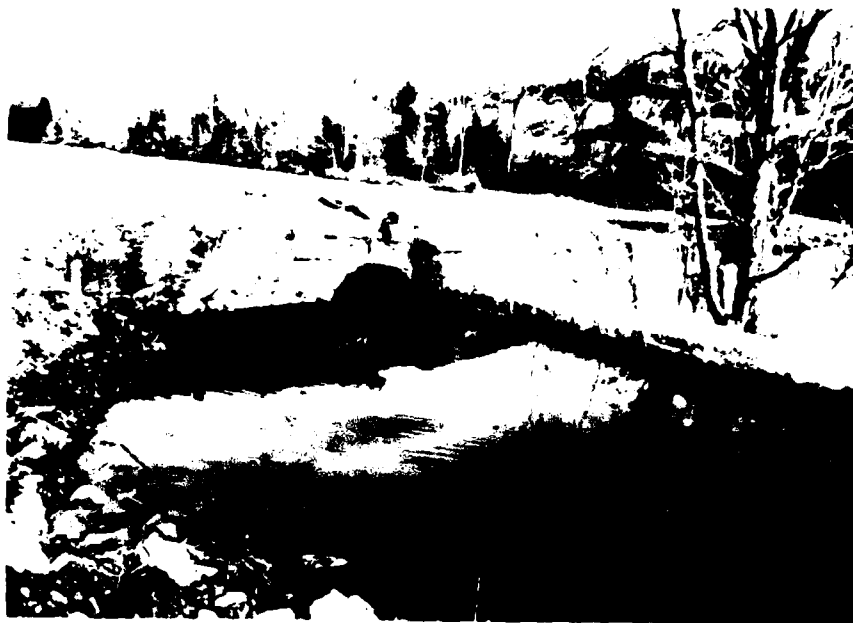
Photo 3 - Downstream headwall of arch culvert and masonry canal wall (3/24/80).

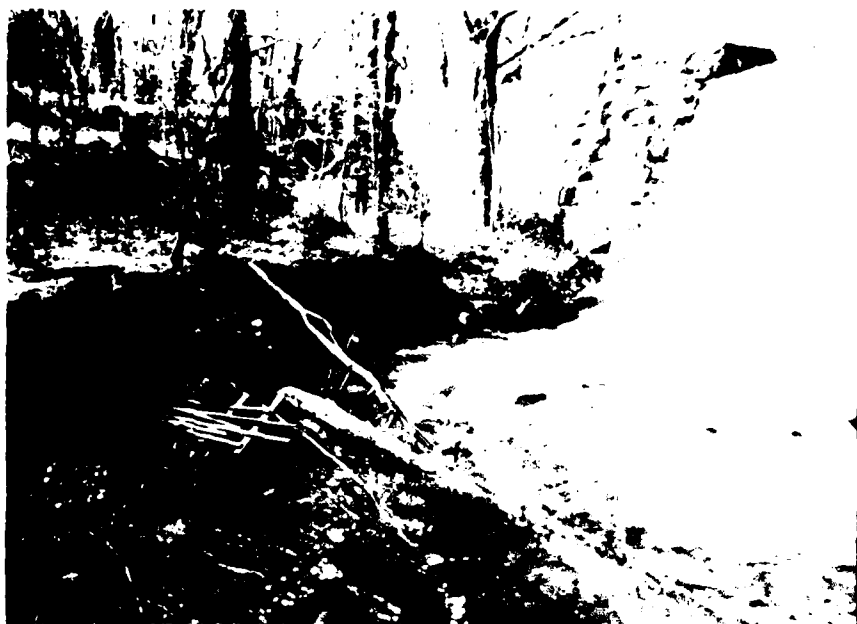
Downstream Face - The masonry downstream face of the dam is mortared on the right embankment, but not on the left. Deteriorated masonry was observed on the downstream face of both embankment sections at a distance of 2 to 4 feet from the edges of the spillway. At these areas the mortar between the blocks is weathered and washed out. Water was observed to be flowing through the joints of the left masonry face at a rate of approximately 6 to 10 gallons per minute (Photo 4). A tree stump, 4 inches in diameter, was noted at the left section near the top of the dam causing a masonry block to be uplifted at this area (Photo 2). Some grass growing from the masonry joints was observed. The toe of the dam is a very heavily wooded area with brush and trees just behind the downstream face (Photo 5).

Photo 5-Downstream face of right embankment. Note trees near toe of embankment and erosion of channel bank (3/24/80).

3. A comprehensive program of inspection by a registered professional engineer qualified in dam inspection should be instituted on an annual basis.
4. Deteriorated masonry of the downstream face of the embankments adjacent to the spillway should be repaired.
